#### Technical Inspection

### Brief Description

Nowadays, composite material is being used widely, namely because of its unique characteristics. QA of parts and laminates made of composite is a challenge. Nevertheless, using UT techniques to perform NDT inspection of such parts provides equally reliable and repeatable results for both in-line and maintenance examination.

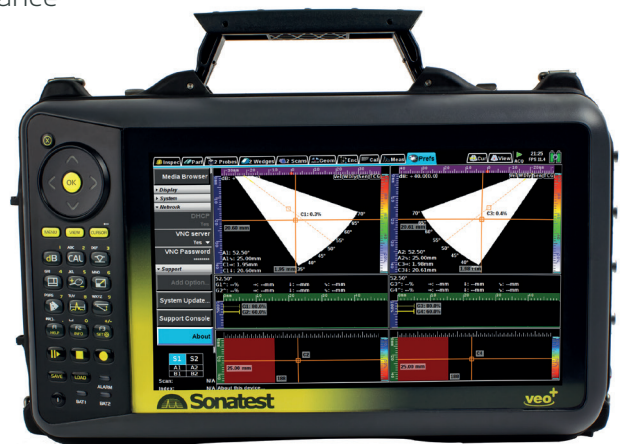
*This application proposes pulse-echo inspection using plastic rexolite, rubber or water delay line.*

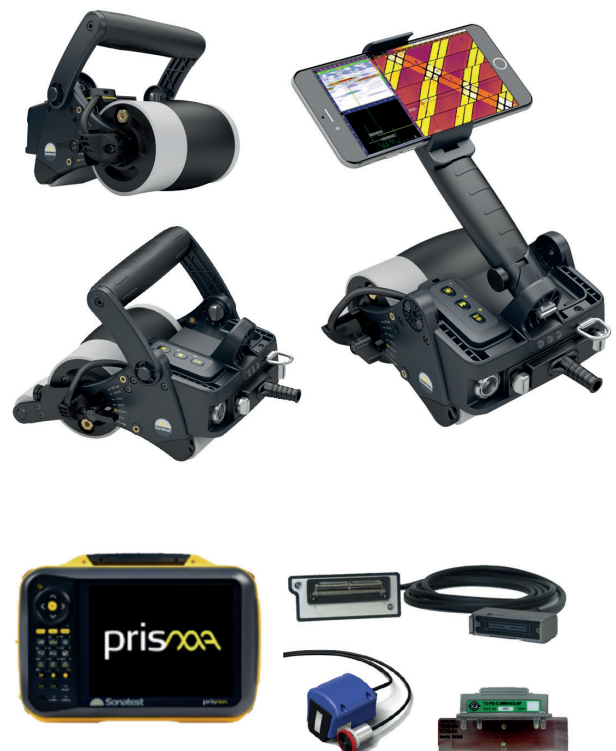
- Sonatest veo+ Wheelprobe2 from 2.25 to 10MHz depending on the thickness and attenuation
- Prisma 16:64 T5 64 elements at 5MHz with encoder or 2-10 MHz Stringer Probe 64-112 elements
