# #UK-1 STANDARD ULTRASONIC TESTING KIT

## THE ULTRASONIC KIT CONTAINS:

8 Plates, 1 Pipe & 1 Tee / Carbon Steel

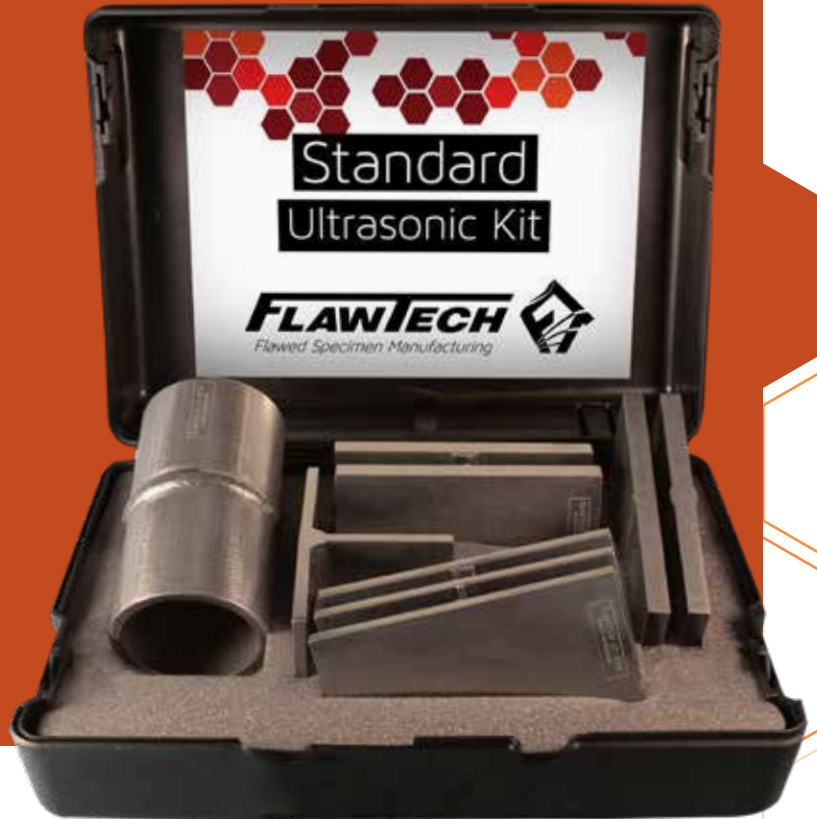
Each specimen contains 2 "REAL FLAWS," randomly placed.

### Kit Specifications: 10 Specimens

(4) Plates: 0.375"T x 4" x 8"

(4) Plates: 0.625"T x 4" x 8"

(1) Tee: 0.375"T x 4" x 8" x 4"

(1) Pipe: 4"Sch80 (0.337"T wall)
